### 3. Acre Lane Parking Survey

24 hour parking surveys were undertaken on Acre Lane, on Saturday, 11 November and Tuesday, 14 November 2023. Parking occupancy was recorded on all highlighted bays on Acre Lane, with length of stay and activity undertaken also noted.

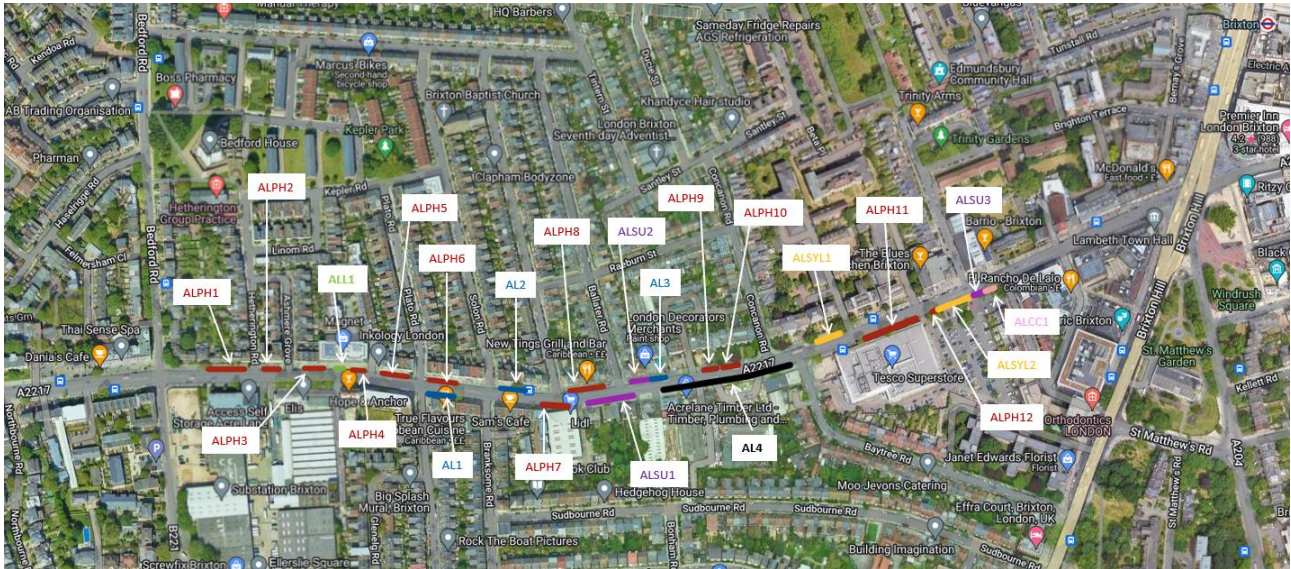
Figure 14 shows the entire length of Acre Lane, along with all areas surveyed and their corresponding reference.

The bays are coloured according to their average hourly occupancy, using the same criteria outlined in Section 2.1. Clicking on each bay will also present information on which activities were undertaken at each bay (for example, parking, waiting, or loading) by vehicles present within that period. Further information on how long each vehicle occupied the bay is also provided.

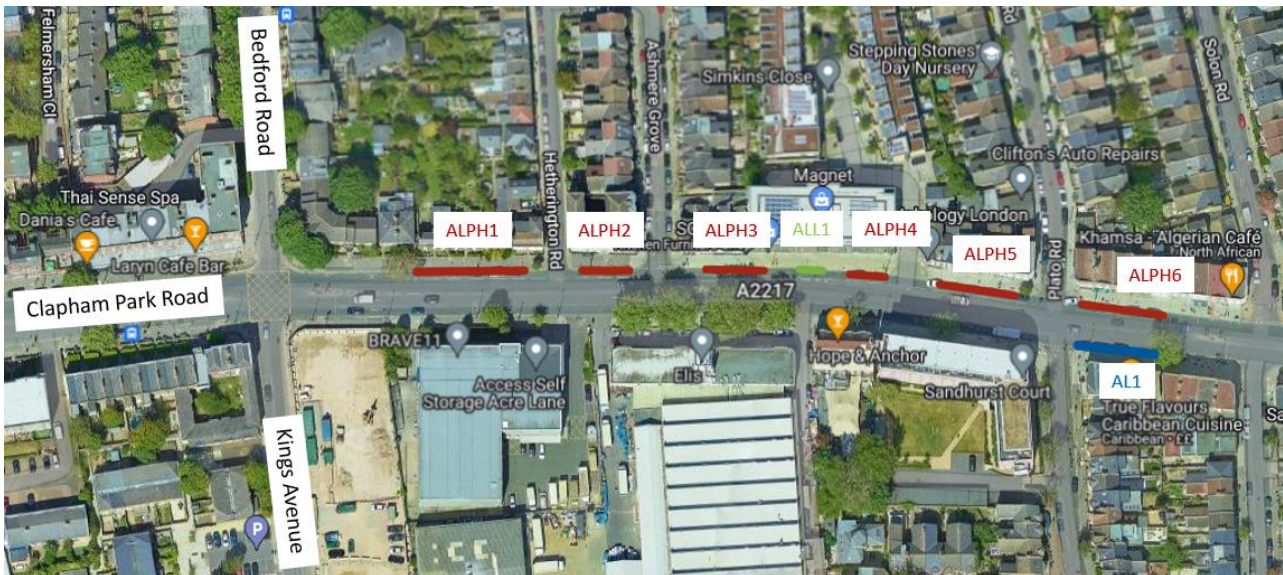
Figure 20: Acre Lane Section 1 parking survey locations

Figure 20 shows Section 1 of Acre Lane, between Bedford Road and Solon Road, along with all areas surveyed and their corresponding reference.

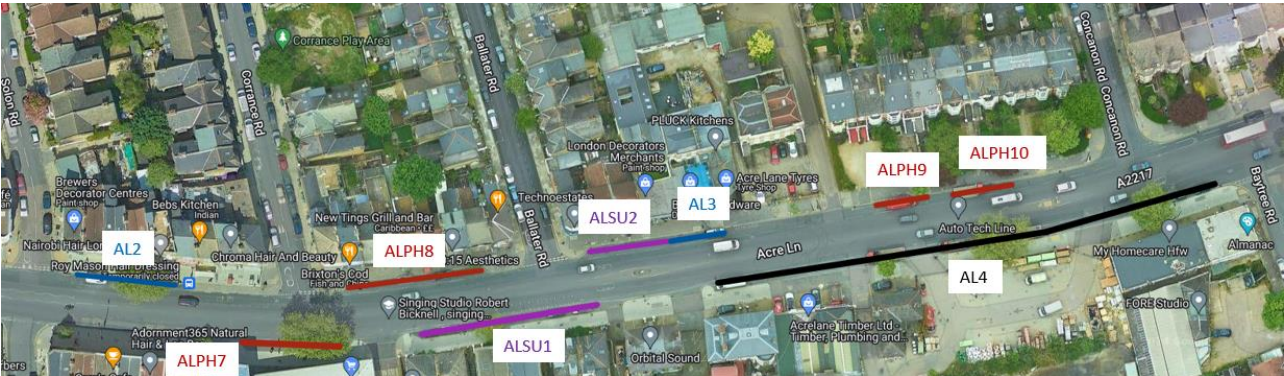
Figure 46: Acre Lane Section 2 parking survey locations

Figure 46 shows Section 2 of Acre Lane, between Solon Road and Baytree Road, along with all areas surveyed and their corresponding reference.

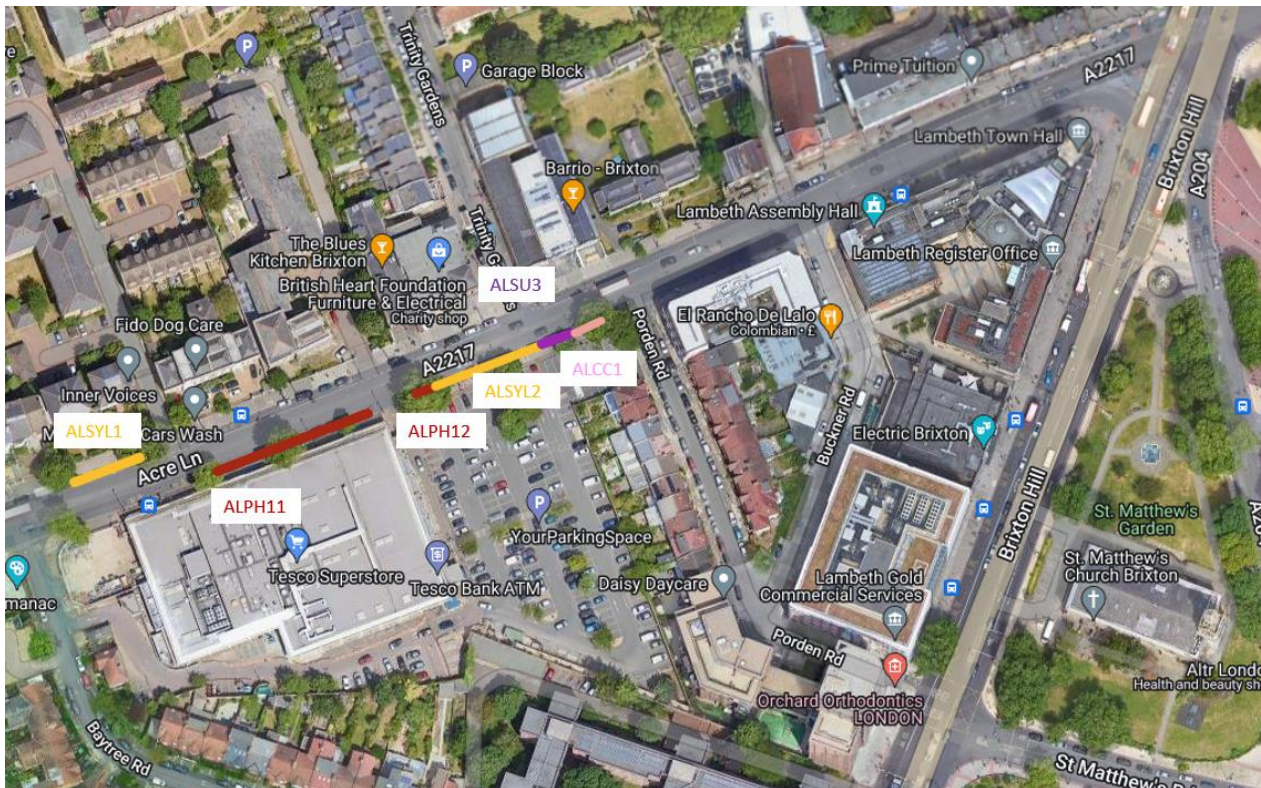
Figure 75: Acre Lane Section 3 parking survey locations

Figure 75 shows Section 3 of Acre Lane, between Baytree Road and the junction with Porden Road, along with all areas surveyed and their corresponding reference.
