## Design Rationale

September 2026

A2199 Bus Priority

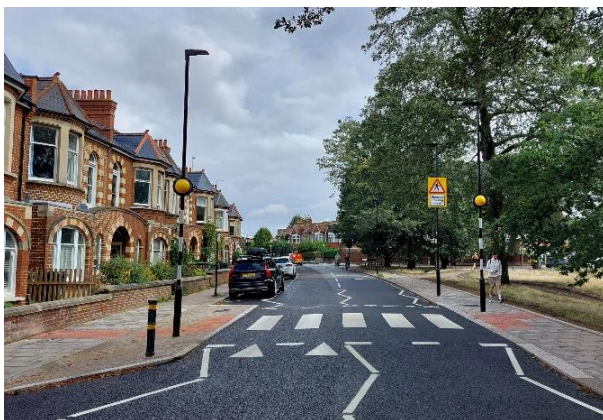
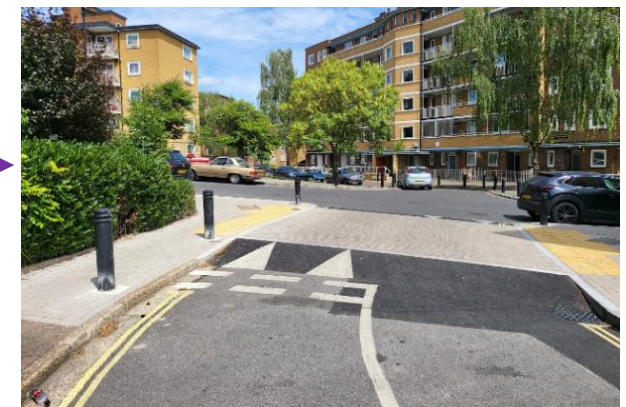
**Example:** Emmanuel Road, LB Lambeth

Continuous crossing  
(funding dependent)

- Initial Engagement comments included crossings for side roads
- Continuous crossings provide clear pedestrian priority to all road users
- Raised crossing encourages drivers to slow down and minimises changes in level for pedestrians
- Tactile paving at either end of the crossing provides an aid for those with accessibility needs

Hawarden Grove

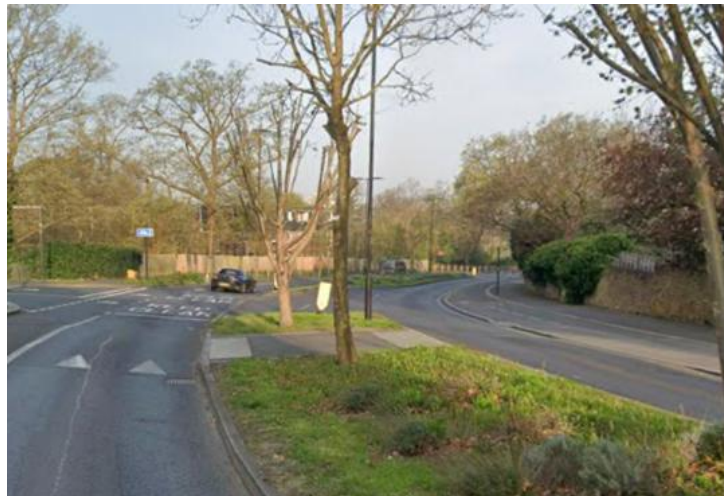
**Example:** Dulwich Wood Avenue, LB Southwark

Informal crossing with buildouts and raised table

- Initial Engagement feedback raised a need for pedestrian crossings, and reducing of vehicle speeds\*
- New crossings provide better connectivity for pedestrians
- Raised table helps reduce vehicle speeds
- Central refuge island allows pedestrians to cross in two-stages during busier periods

1. Croxted Road (adjacent to Dalkeith Road) **See Design Sheet 2, Page 1**
2. Croxted Road (adjacent to Pymers Mead) **See Design Sheet 2, Page 1**

\*Over 40% of vehicles travel above the speed limit along this section (see data report, page 12)
